Case Reports

Endovascular Management of Stent Fracture Causing Trans-jugular Intrahepatic Portosystemic Shunt Stent Malfunction

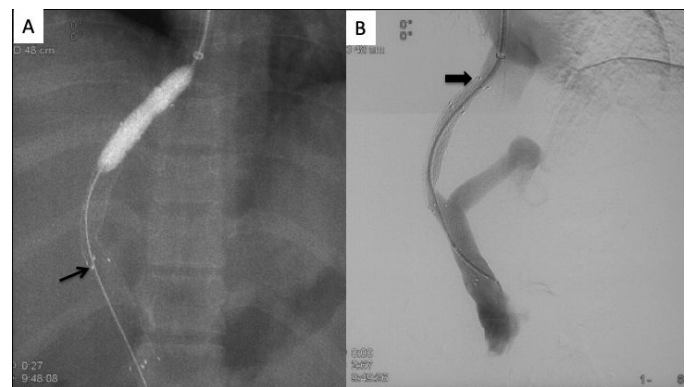
Figure 1: DSA spot images (A, B) of TIPS created in 2015 showing configuration of the overlapping uncovered and covered stents (arrow) with good flow across the shunt (Block arrow).

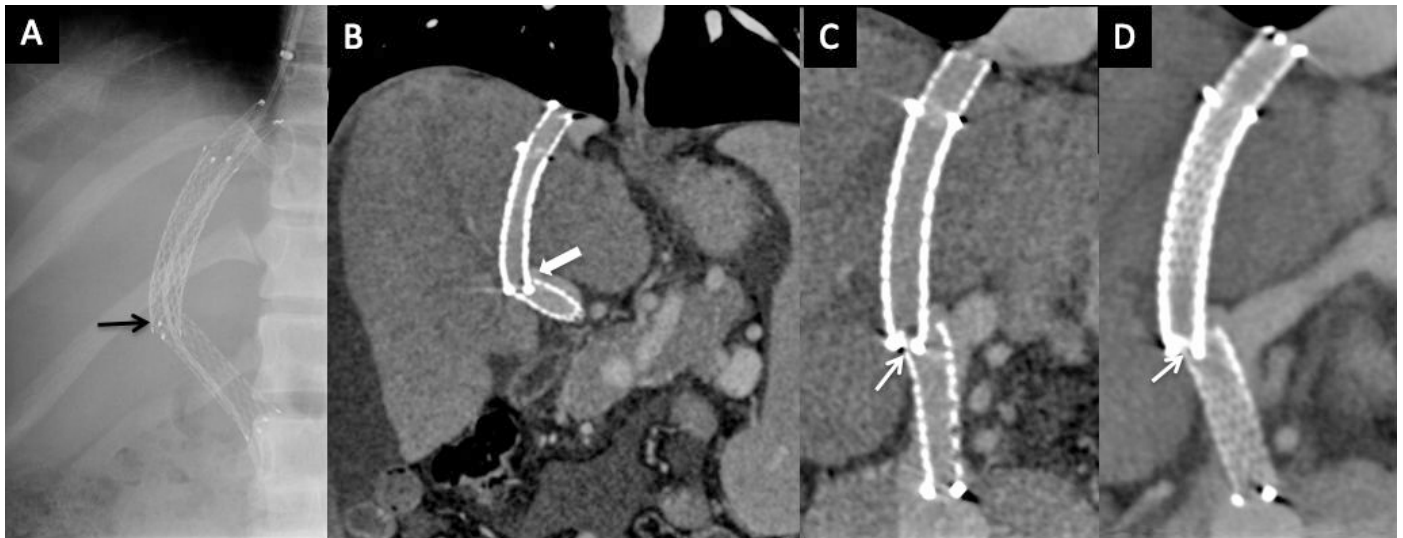
function tests as a part of the workup to evaluate ascites. Liver function tests were normal. A CT portography was done to look for any abnormality in the TIPS stent. CT portography revealed a normal flow of contrast through the stent. However, there was acute angulation noted at the junction of covered (Fluency Plus, Angiomed GmbH/C. R. Bard, Inc., Karlsruhe, Germany) and uncovered stents (E-Luminexx Vascular Stent, Bard Peripheral Vascular, Tempe, Arizona) with the fracture noted in the uncovered stent with the fractured segment of stent protruding into the lumen and reducing the circumference of shunt lumen (Figure 2, Figure 3). TIPS revision was planned, because of persistent ascites, to correct abnormal stent morphology due to fracture of the uncovered stent. Diagnostic angiogram of TIPS stent revealed flow across the shunt without any thrombosis. A 10 mm x 10 cm covered stent (Fluency Plus, Angiomed GmbH/C. R. Bard, Inc., Karlsruhe, Germany) was placed centered at the site of fracture. Post covered stent placement, there was a correction of the abnormal angulation of the TIPS stent and the fractured stent was no longer causing any luminal impingement. (Figure 4) There was complete resolution of ascites at one month follow-up, and Doppler showed normal flow (>100cm/sec) across the TIPS stent.

Figure 2: Plain radiograph of RUQ (A) showing bend at the junction of the uncovered and uncovered stent (black arrow). Coronal 3D reformatted CT images (B-D) showing fracture of the uncovered stent at the junction of uncovered and covered stents (block arrow) with the fractured segment of the stent protruding into the lumen (white arrows).

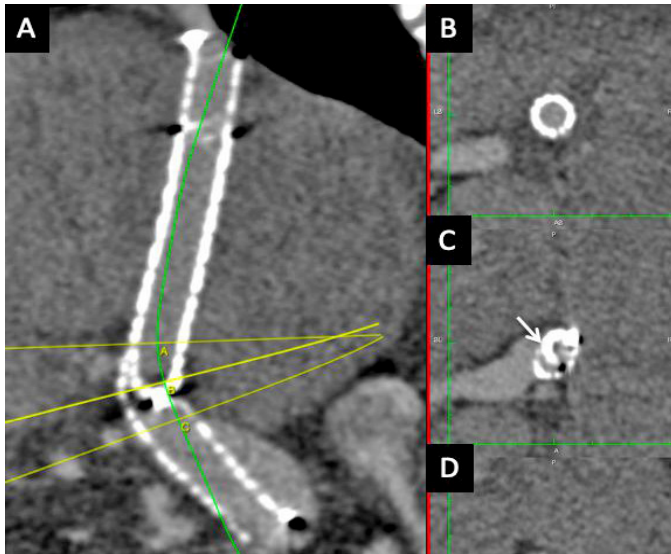
Figure 3: Curved MPR image (A) with axial reconstructions at various levels of the shunt ((B-C) showing a normal configuration of the stent at distal (B) and proximal (D) to fractured segment protruding into the lumen and reducing the circumference of shunt lumen (C) (arrow).

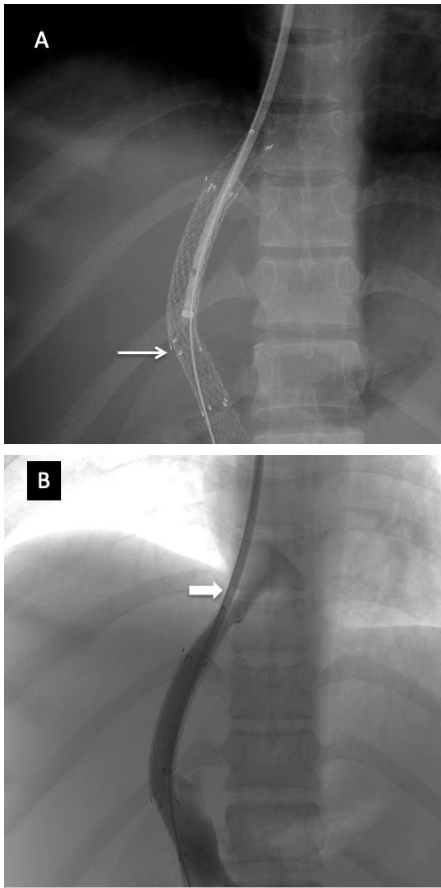
Figure 4: DSA spot images (A, B) after TIPS stent revision showing abnormal angulation at the level of fractured segment is no longer seen (arrow) with good flow across the shunt.

TIPS stent fracture is very rare and the presence of TIPS stent angulation and use of overlapping covered and uncovered stents increases the risk of stent fracture with the most common site being the junction of covered and uncovered stents. The use of a single piece stent like the VIATORR stent-graft (Gore, Flagstaff, AR, USA) is thus ideal to decrease the risk of stent fracture rather than using two overlapping stents. Our case is unique compared to the other case reports because it represents the first case of TIPS stent fracture at the portal venous end of the stent with no displacement of the fractured fragment. Our patient was symptomatic and responded to stent revision with a covered stent graft across the fractured segment.
